Nashville, TN  
March 11-15, 2012

### Paper F-3-03

## CURED IN PLACE LINER DEFECTS- THREE STUDIES OF INSTALLED LINER PERFORMANCE QUALITY

James W. Shelton, PE<sup>1</sup>

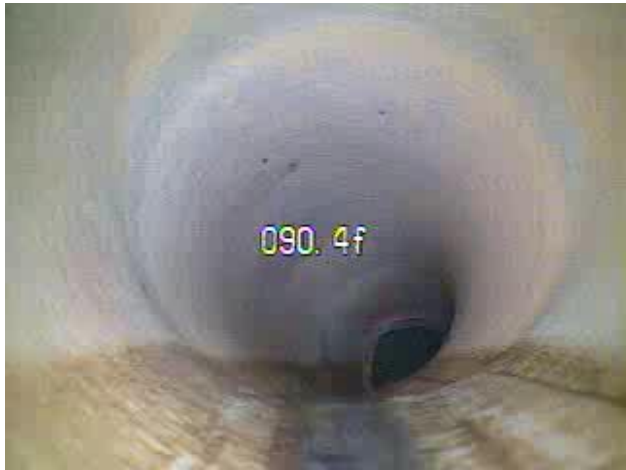
Figure 1. Immediately After Installation Inspection

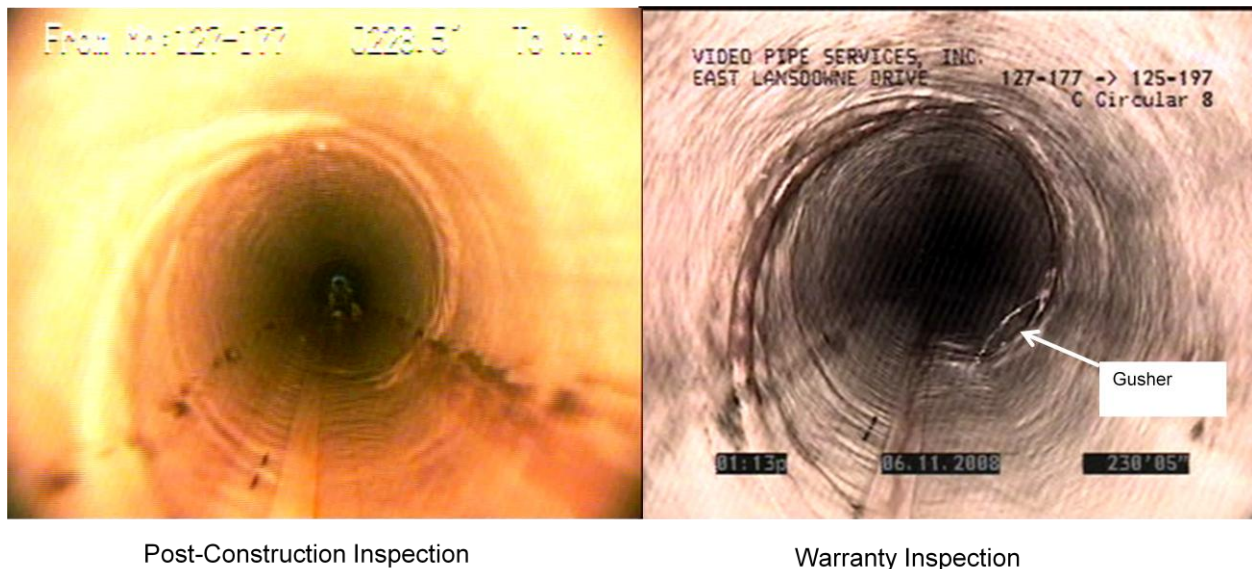
**Pinhole Defects** – The most prevalent defects found at Post-Rehabilitation Inspection are pinhole leaks in the body of the liner. These pinholes are most typically expressed as orange or red staining; as most inspections are not conducted during rain events nor during the seasonally high groundwater periods, active leakage is not typically photographed, although we do have enough instances of inspections during wet weather/high groundwater showing the same pinhole alternately actively leaking and showing only DAE to confirm that these pinholes do indeed leak during wet conditions. (It is important when evaluating pinhole leakage not to misrepresent black or brown stains as leakage, as these are typically bacterial growths blossoming under the inner coating or on the follicles of the exposed resin-tube following film removal (in the case of PU or PP film erosion/dissolving) or calibration tube removal (in the case of liners without integral interior films). As most of these projects are I&I reduction driven, and these sewers were lined to eliminate leakage long term, the presence of leakage through the body of the liner only weeks after installation is especially disconcerting, and begs the question of what will the leakage characteristics be near the end of the liner's life (typically 50-100 years, depending on the design requirements of the project/utility).

Figure 2. Time/Season dependent evidence of leakage

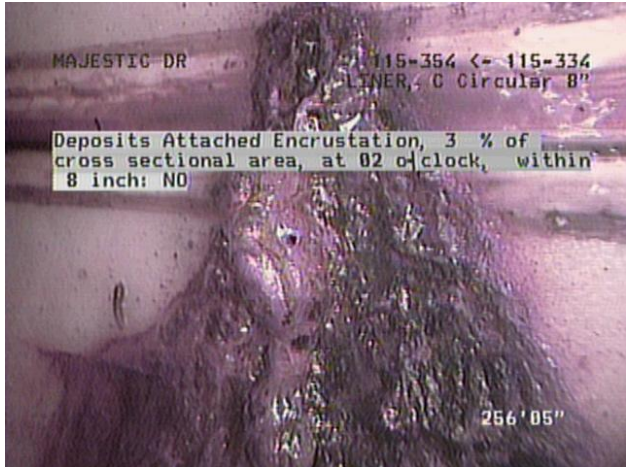
Our data show that 41% of the mainline liners installed suffer from pinhole leaks in the body of the liner at the Post-Rehabilitation Inspection. Disconcertingly, the percentage of pinhole leaks in the body of the liner increases to 52% at the Warranty Inspection, and the degree of leakage at previously evident pinholes has generally increased. Similar results were obtained for lateral liners, with 13% of the lateral liners installed suffering from pinhole leaks in the body of the liner at the Post-Rehabilitation Inspection, and 25% at the Warranty Inspection. Again, the degree of leakage at previously evident pinholes often increased.

Figure 3. Pinhole Leakage on mainline liner

There appears to be no differentiator between materials, manufacturer, contractor, or installation method when considering these defects. The only liners without significant pinhole leaks appear to be the thicker liners installed in larger diameter pipe. Our data are currently insufficient to determine the breakpoint in the pinhole:thickness relationship.

To address **water droplet explosion** and **inherent porosity of the liner**, specifications have been rewritten to require the contractor to regulate the heating up of the liner, promoting a longer warm-up period to allow air bubbles more time to migrate from the bag, water droplets more chance to find an outlet outside the liner, and water vapor bubbles a chance to migrate from the liner before resin hardening. Specifications currently being used state:

To address **water droplet explosion, inherent porosity of the liner, and inner film pinhole with follow-on blowout of resin**, specifications have been changed to require thicker than F1216-required liners. When the F1216 calculations for liner thickness for:

- 8” and 10” pipes yield liners 6mm or thinner on for non-woven liners, specifications now *require a 7.5 mm minimum thick liner*.
- 8” and 10” pipes yield liners 3.2mm or thinner on for fiberglass reinforced UV cured liners, specifications now *require a 4.8 mm minimum thick liner*.

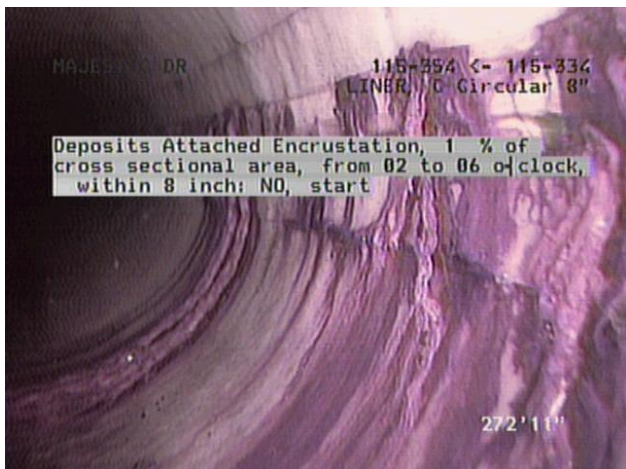
**Seam Defects** – Seam defects occur primarily along the longitudinal seams of non-woven felt liners. These defects are most typically expressed similar to pinhole leakage, with the exception that the leakage is usually linear rather than points. The problem is often exacerbated when the inner white strip commonly installed on non-woven liners begins to break free.

Figure 4. Seam Leakage on mainline liner

The data show that 0.3% of the mainline liners installed suffer from seam leaks at the Post-Rehabilitation Inspection. Disconcertingly, the percentage of seam leaks increases to 24% at the Warranty Inspection, and the degree of leakage at previously evident seam leaks has generally increased. Similar results were obtained for lateral liners, with 8% of the lateral liners installed suffering from seam leaks at the Post-Rehabilitation Inspection, and 13% at the Warranty Inspection. Again, the degree of leakage at previously evident seam leaks often increased.

Seam defects seem to be related to longitudinal seams are tightly stitched, are butt-seamed (i.e., non-overlapped), and/or have inner or outer seal tapes that are applied using flame bonding or chemical bonding in such a way that decreases the ability of the felt to retain resin in/near the seam. We have not yet conducted enough analysis of these defects and the specific stitching and seal tape bonding to accurately assess the effect of these variables. The only liners examined that did not suffer from seam leakage are those that are thick liners installed in larger diameter pipe,

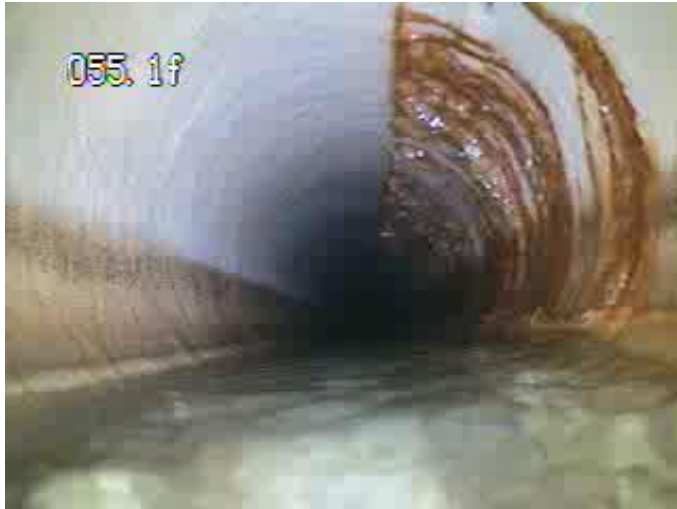
Figure 5. Seam Leakage on lateral liner

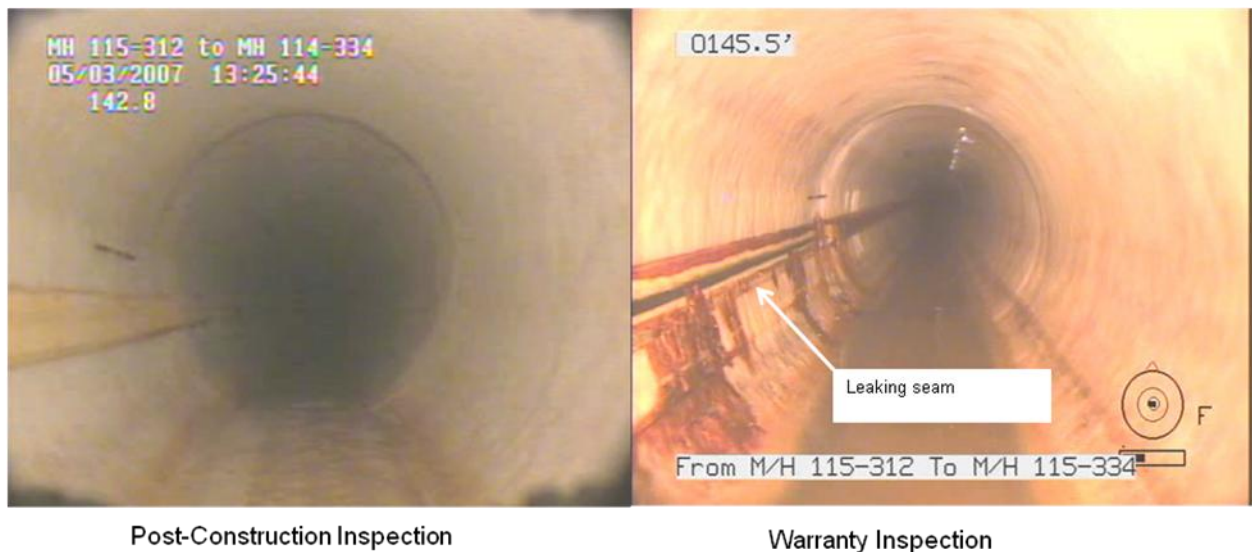
Figure 6. Seam Leakage evident over time

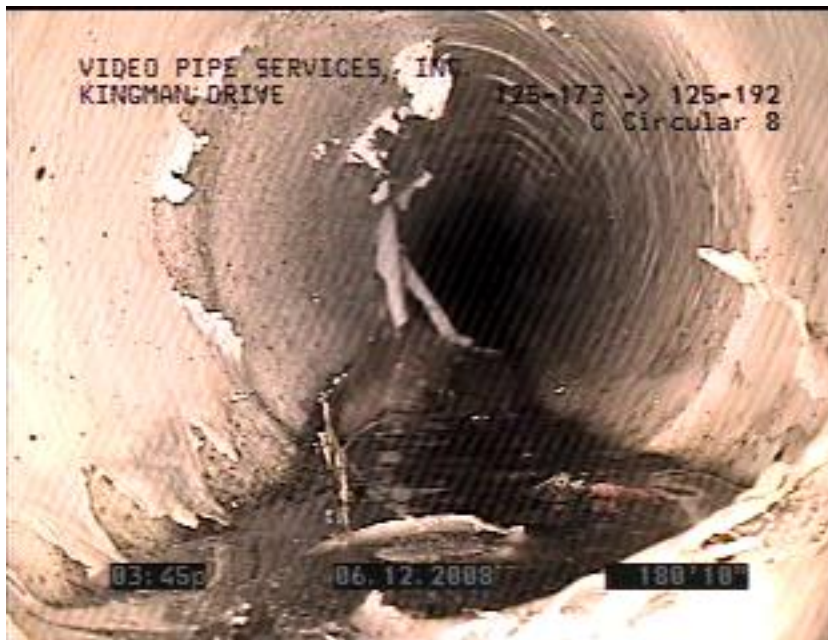
Initially thought of as dissolution or erosion of the film coating, we are beginning to appreciate that in some cases the loss of the coating is more like delamination than eroding or dissolving. This delamination presents itself in three formats:

- Piecemeal loss of coating with no appreciable blockage of flow but with the attendant increase in liner body leakage and the roughening of the flow surface. This is the normally anticipated deterioration of the coating;
- Sheet delamination, often with significant bubbling underneath the coating and the formation of pipe blocking lifts, the potential significant blockage caused when the sheet releases partially or fully, and the roughening of the flow surface when the delamination is complete;
- Strip delamination or erosion, with a significant increase in debris, rag, and grease accumulation caused by the greatly increased surface area in the flow path, followed by the roughening of the flow surface when the delamination is complete.

Figure 7. Lateral liner coating delamination

**Differential shrinkage of the coating vs. cured liner** – Delamination of the coating is caused by differential shrinkage between the coating and the cured liner. As the cured polyester liner shrinks, the coating buckles at weak spots in its connection to the liner. This release, coupled with the expected dissolution of the coating, creates the noted sheet and strip delamination issues documented.

To address **coating delamination**, both thinner and thicker coatings are being field trialed. The thought is that thinner coatings will dissolve more quickly and cause fewer potential O&M issues, and that thicker coatings might not delaminate via buckling failure from differential shrinkage, but might more evenly dissolve.

To address **Differential shrinkage of the coating vs. cured liner**, specifications have been rewritten to require the contractor to regulate the cool down of his liner, promoting a longer tempering/acclimation period. Specifications currently being used state:

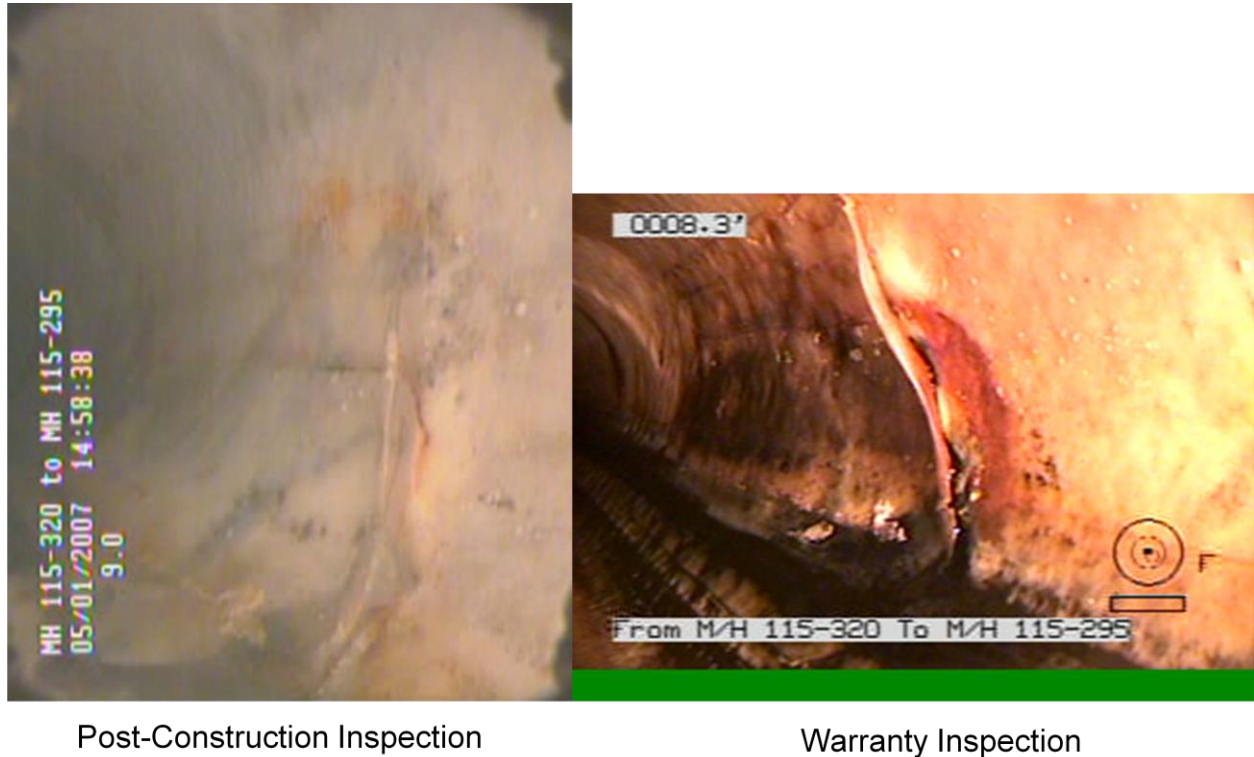
**Inner film pinhole with follow-on blowout of resin** – The coating on all heat cured liners is very thin (8-15 mils). Various manufacturers apply this coating in a variety of ways and test the liner for holidays before shipping for tube fabrication. This testing confirms coverage, but not necessarily minimum thickness. Then during tube manufacture and wet out, this coating undergoes a variety of stresses, some common to all products, some unique to the manufacturing process. Non-woven felts are all sewn together, creating thousands of small punctures intentionally, and unaccounted unintentional pricks. During wet out, holes are intentionally punctured into the coating for vacuum impregnation; these are subsequently sealed, but have the inherent potential weakness of any human applied patch.

Figure 10. Detached Factory Patch Found at Warranty Inspection
