# USING CHEMICAL GROUT TO CONTROL GROUNDWATER INFILTRATION

JIM GENTRY<sup>1</sup> and DANIEL MAGILL<sup>2</sup>

Chemical grouting has been successfully used for over forty years to control the movement of groundwater in a wide variety of applications including tunnels, subway systems, sanitary sewers, mines and construction projects. This paper illustrates the versatility of chemical grouts by reviewing three projects featuring acrylamide grout for difficult water control challenges and a fourth project using urethane grouts for stabilizing soils, filling voids and lifting concrete slabs with structural, high-density foam. Controlling groundwater aids in solving structural problems before, during, and after construction.

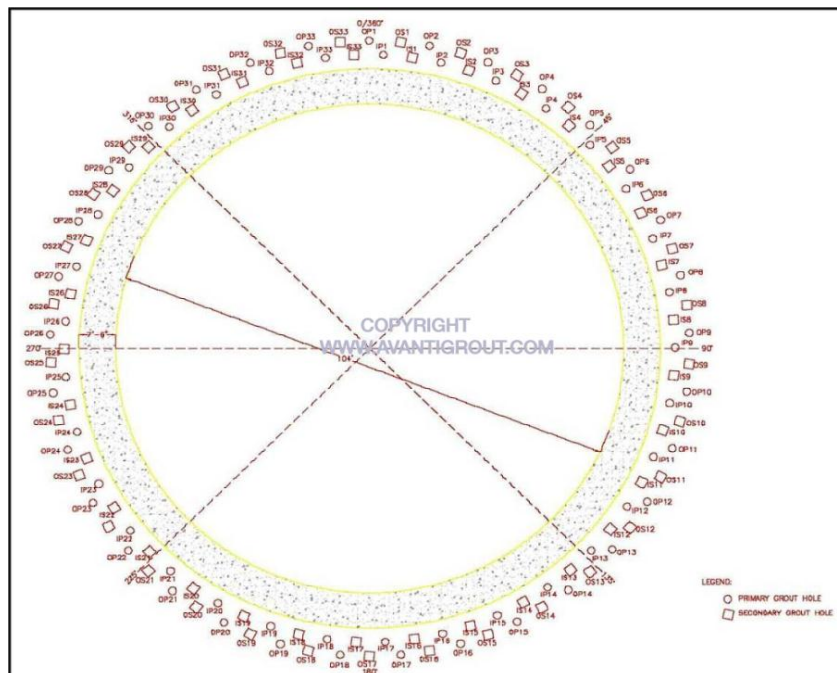
Figure 1. Grout holes on the perimeter of the shaft

Engineers and consultants elected to perform a pre-excavation grouting program around the perimeter of the two shafts prior to construction to prevent problems with water and gas entering the shafts during excavation and construction. The grout selected was required to meet the following performance criteria: i) Very low viscosity in the range of one-two cps capable of penetrating all of

An infiltration rating of two lugeons in the soil around the two shafts was established by engineers as the maximum water infiltration that could be accepted. Two grout curtains were established around the shaft perimeters, the outer curtain was formed using cementitious grout and the inner and less permeable curtain was formed using acrylamide grout. Testing revealed that the grouting program achieved a final permeability of 0.2 lugeons, ten times better than the specified objective.

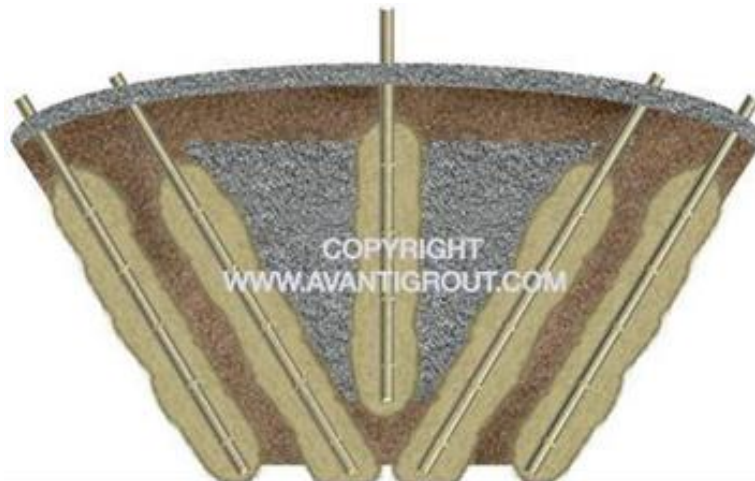
**Figure 2.** Acrylamide chemical grout injected via probes to encapsulate hazardous waste, cementitious grout in the trench and acrylamide grout in the soil adjacent to the trench

The project entailed encapsulating a large volume of mixed liquid and solid waste from the Manhattan project that was stored in several trenches at the facility. The largest of the trenches, trench five, is 300' long, 10' wide at the surface, 15 feet deep and 4' wide at the bottom of the trench. Polyethylene sheeting was originally used to contain the waste in the trenches. Fractures subsequently developed in the geology surrounding the trenches providing pathways for the contaminated liquid to seep into the soil and also into the groundwater which was located about 25 feet below the bottom of the trenches. To contain the waste material in the trenches, cementitious grout was injected into the trenches and acrylamide grout was injected into the surrounding soil to encapsulate the waste material. Injection of the grout was accomplished using sleeve pipes with rubber sleeves that function as valves to allow the grout to exit but prevent any contaminated material from exiting the trench. After completion of the project no further contamination has been noted in any of the monitoring wells around the project site.

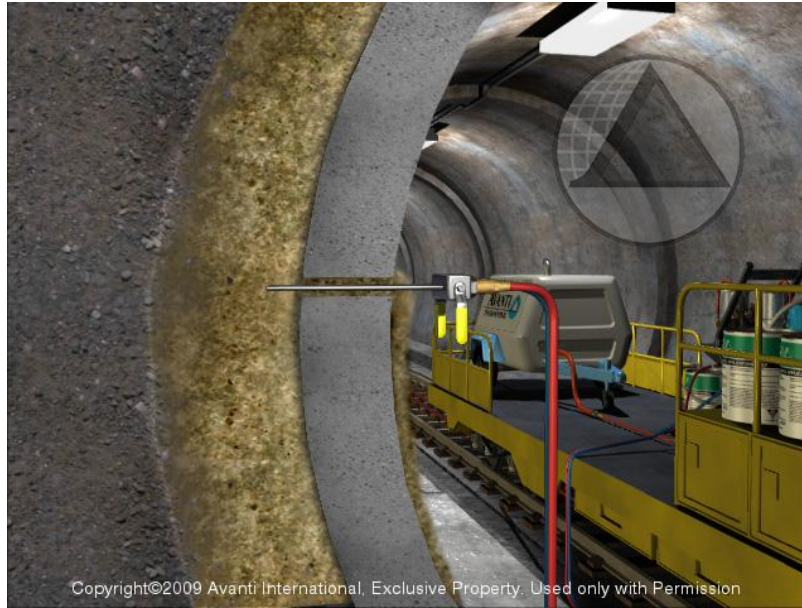
**Figure 3.** Chemical grout permeating the soil to create an impermeable grout curtain

impermeable soil/gel water barrier or curtain around the tunnel exterior. Extensive testing revealed that acrylamide grout was the best product for use under the challenging geological and hydrological conditions. The tests included the viscosity of the product (one-two cps), permeability of the grouted soil, ability to control gel set times to accommodate the varying geological and hydrological conditions (a few seconds to several hours), the longevity of the applied grout (US DOE tested to have

The mechanism for water infiltration into the tunnels is predominantly via the expansion and construction joint systems. The groundwater table is typically above the tunnel roof and is the source for all of the water infiltration problems. The grouting repair technique that has been successfully used to stop the water infiltration into the tunnels is curtain grouting. Curtain grouting creates a curtain of grout in the soil outside of the structure thereby preventing the water from contacting the structure surface. Acrylic grout is injected into the soil surrounding the tunnel structure where the grout permeates the voids in the soil and sets to form an

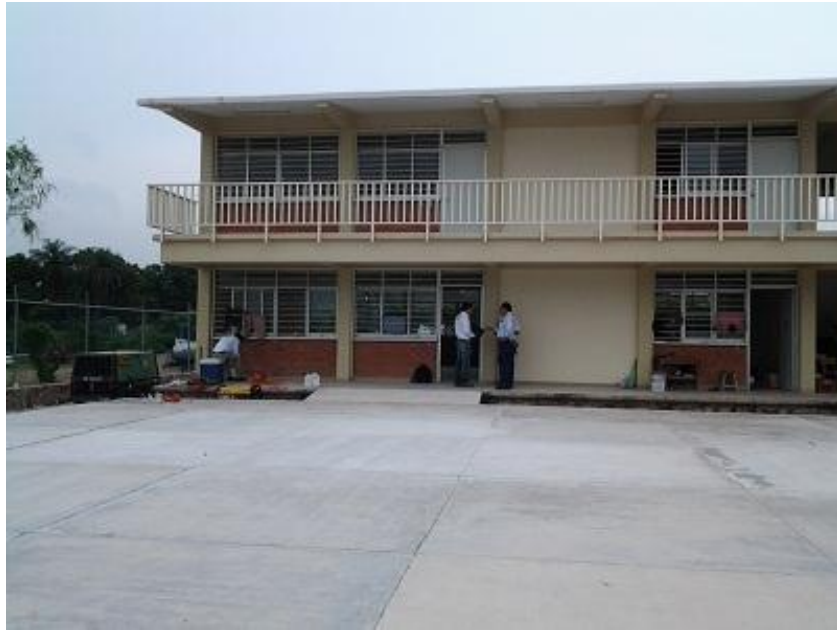
**Figure 5.** Photograph of the west end of the school building near the retaining wall
