Lateral Sealing in Wisconsin Provides Opportunity for Innovation

The Village of Brown Deer, Wisconsin, just wanted to address an ongoing problem in one of its residential subdivisions that resulted in high inflow and infiltration at one of its interceptor sewers as far back as 1996. In correcting the problem, Village officials did not want the work to take place on the private property of the residents.

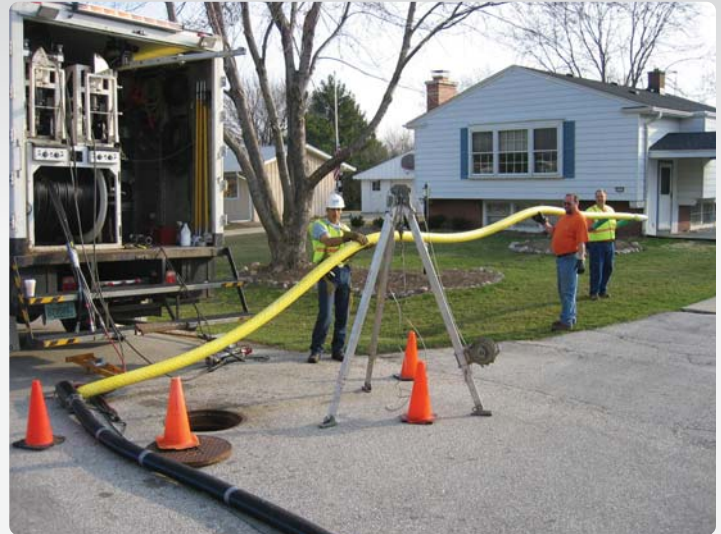
The 38-ft long Logiball Packer.

Logiball decided to build and try the 38-foot long lateral packer. All the operations were working aboveground (inversion and retraction of the 38-foot long lateral bladder). The equipment was tested in the shop before the project went out to bid, Anctil said.

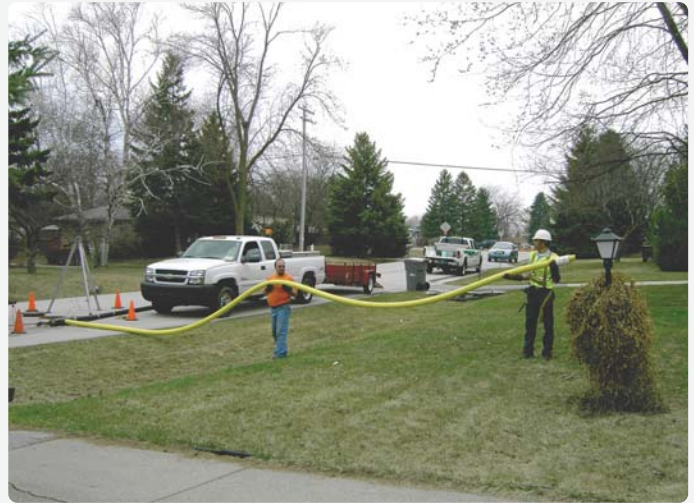
Lateral bladder extended out ready for lubrication.

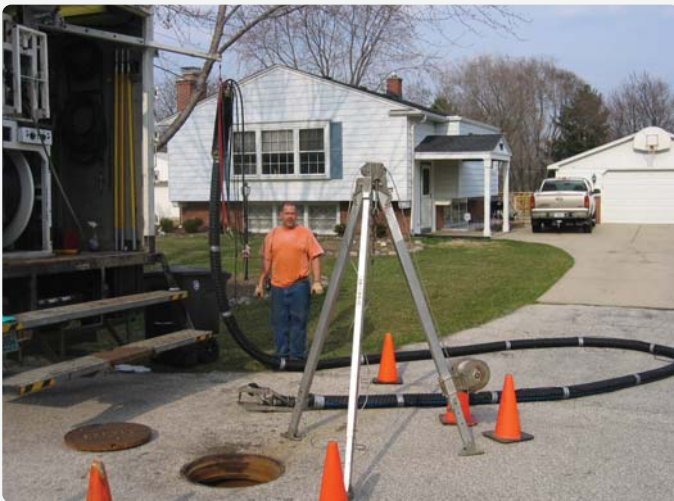
Great Lakes TV & Seal’s Greg Healy stands beside the packer just brought out of the sewer with help from the bumper crane.
