### Rembco Undertakes New Project for Hazardous Waste Containment at ORNL

## Rembco Undertakes New Project

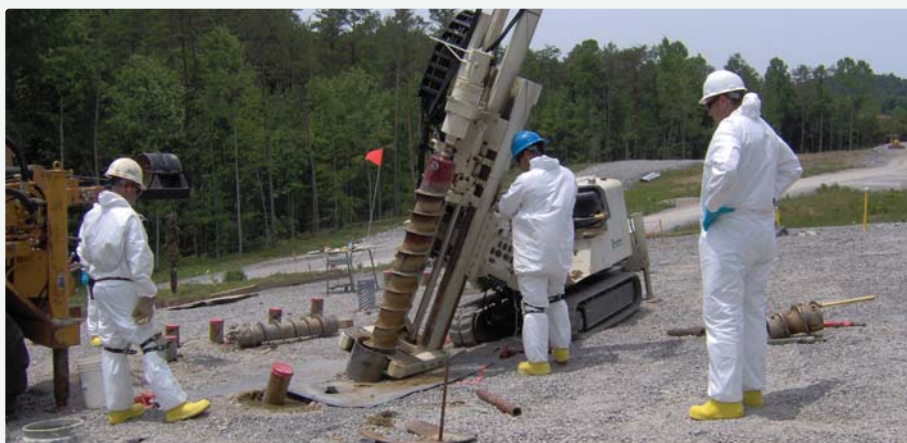
Collar pipe installation at ORNL trench.

The approach to the new project will be similar to the approach used in 1996. Collar pipes are 5.5" O.D. and are installed through the gravel and asphalt cap a couple of feet into the soil. The sleeve pipes are 20 to 30 feet long and driven in one piece. These pipes have rubber sleeves covering holes drilled every 2 feet down the pipe. The sleeves function as valves, letting grout out but not letting contaminated groundwater in. A double packer is positioned over an individual sleeve port and the grout is injected (cement grout in the gravel trench, acrylamide in the surrounding soils). Collar pipes are installed in augured holes and grouted in place. The sleeve pipe is driven inside the collar so any grout or contaminated material that comes up will be contained.

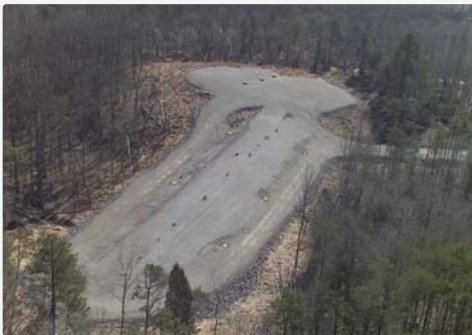
An aerial view of Trench 5

The current scope of work includes insitu-grouting of two trenches and seven wells, all of which were constructed or installed in the 1960s. The longest of the trenches, Trench 5, is approximately 300 feet long, 10 feet wide at the ground surface, and 4 feet wide at the bottom of the trench. This trench was 15 feet deep and was layered with 1.5" to 2" diameter of crushed stone to a depth of approximately 10 feet.

Polyethylene sheeting was placed over the top of the crushed stone and the trench was backfilled with soil. The water table was determined to be about 25 feet below the bottom of the trench. Approximately 9.5 million gallons of contaminated liquid waste was then

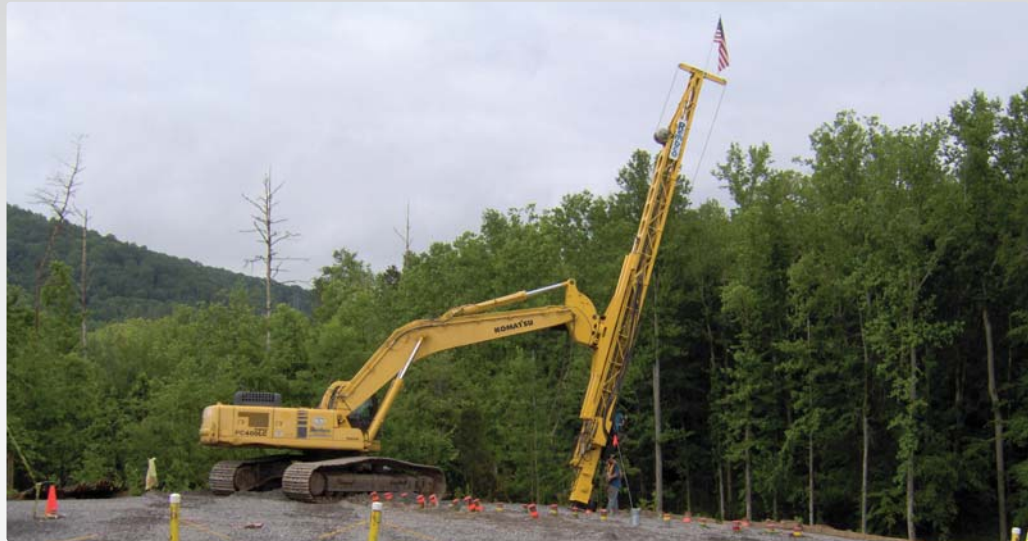
The sleeve pipe driver is a 42-foot mast with a hydraulic hammer.
